Manhole Inspection Summary

Manhole # S3700_011MH

Insp Date: **1/29/07 12:23 PM**

Location Address: **2239 HOMEWOOD AVE**

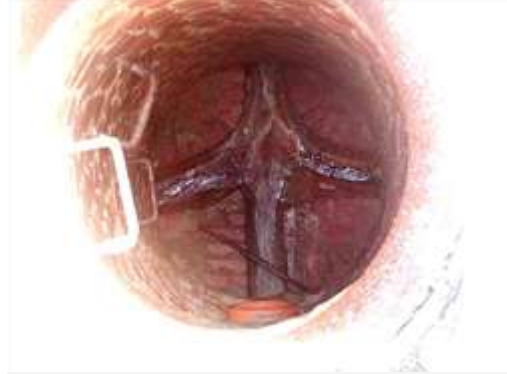
Top View

☒ **Debris** (not Condition related)

☒ **Corroded**

Corroded steps. Bench debris.

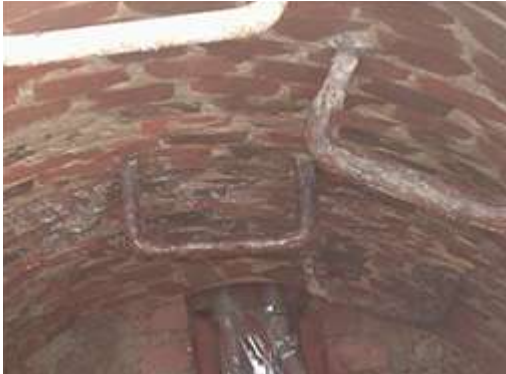
Defect

Infiltration: ☐ None ☐ Joint ☐ Cracks ☒ **Mortar** ☐ Roots ☒ **Wall**

Barrel infiltration.

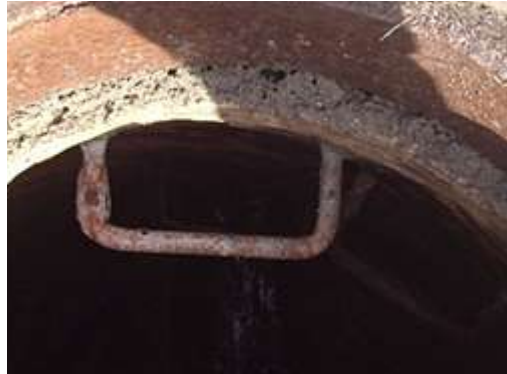
Defect

Offset: **2** (in.)

☒ **Leaks**

Frame leaks. Frame offset.

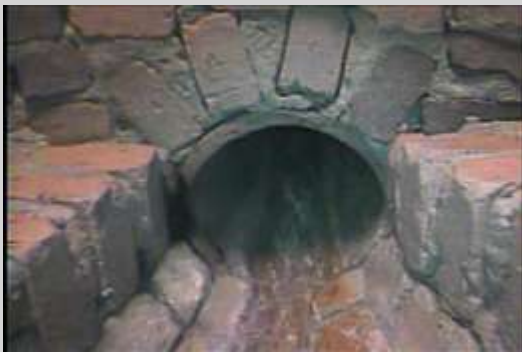
8 in. Circular Gravity Sewer Pipe Out @ 12 O'Clock

Barrel deterioration and infiltration. Channel deterioration.

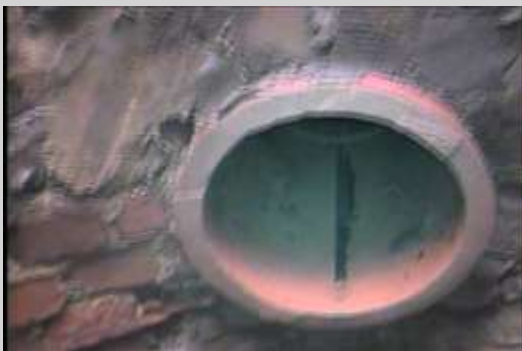
8 in. Circular Gravity Sewer Pipe In @ 6 O'Clock

Barrel infiltration and deterioration.

Infiltration: **Evidence** Pipe Seal Cond: **Unknown**

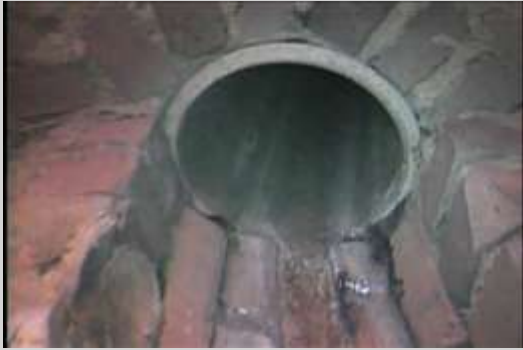
Pipe In @ 9 O'Clock

Channel deterioration.
